Northwest Research Institute, Inc. Carbide Processors, Inc. 3847 S. Union Ave. Tacoma, WA. 98409 800 346-8274

Carbide Braze Failure Due To Machining Of the Steel Holder

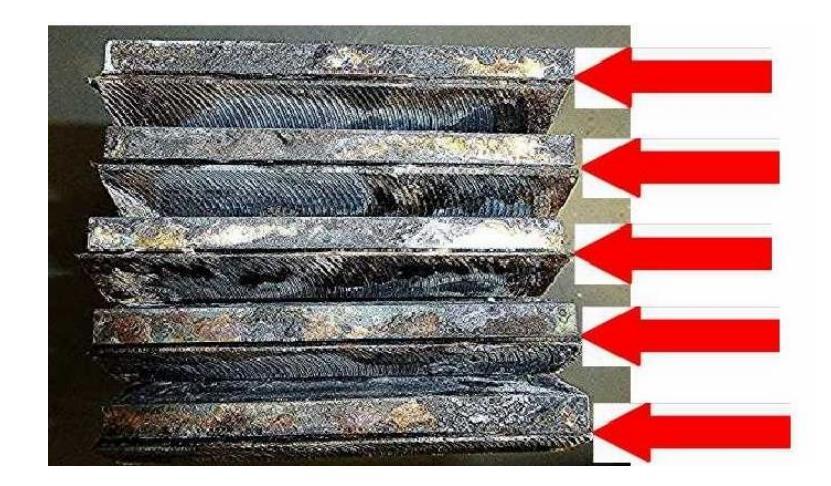
Analysis Of The Braze Parts Showed A Gap Between The Carbide And The Steel.

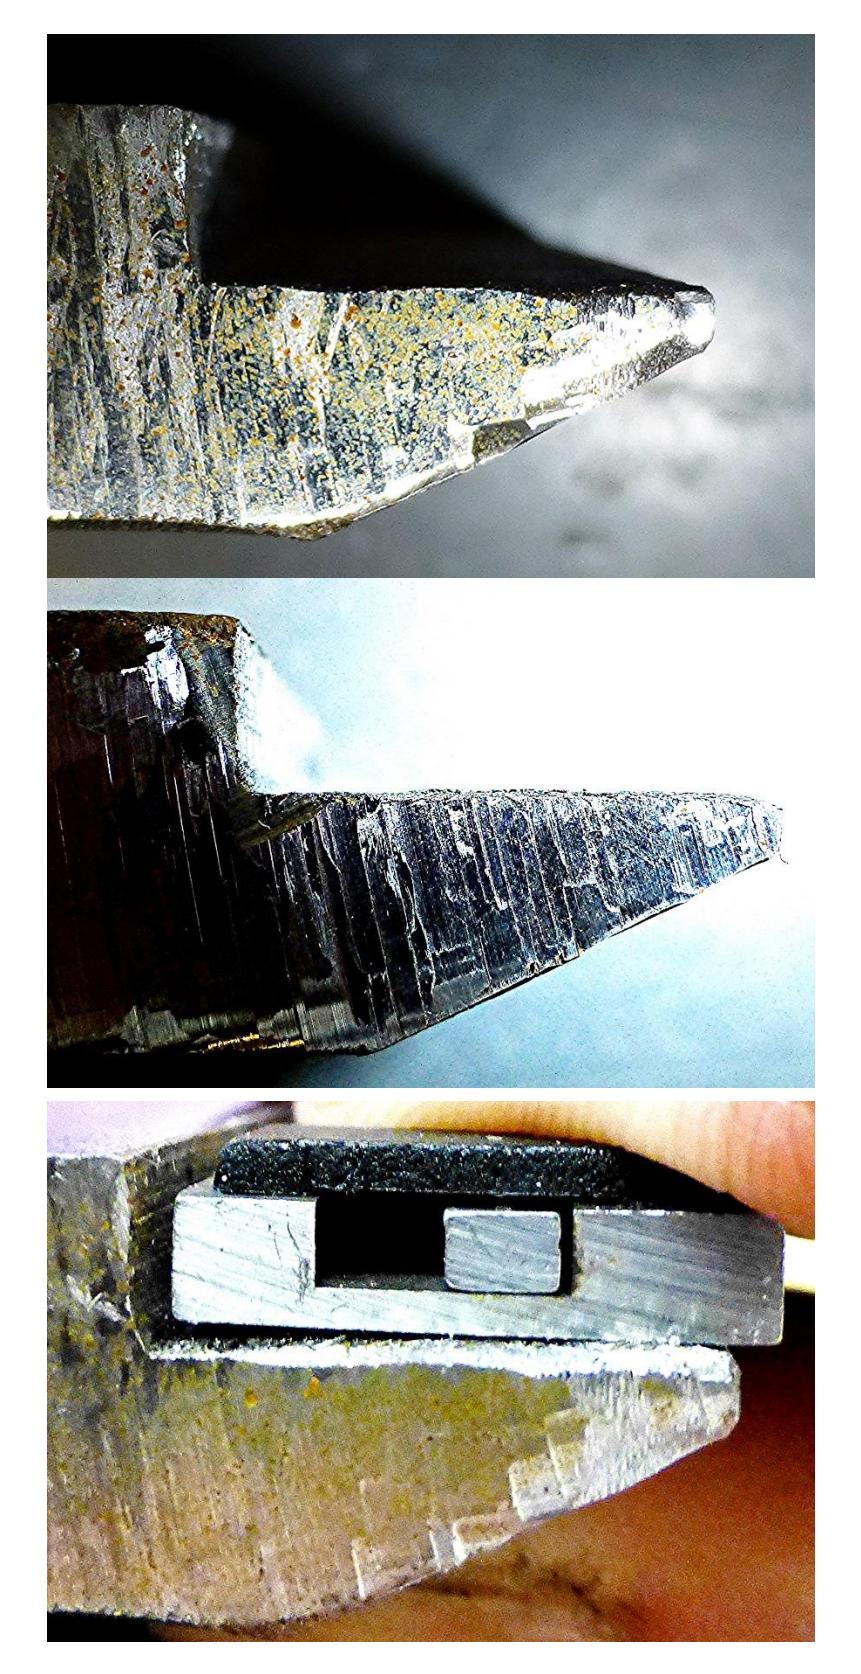
Analysis Of The Steel Holders For Flat And Square

There tends to be a trough running In front of the back wall. The front lips tend to bend down. The back wall tends to slant out

Part of the Cause of failure was the unevenness of the steel.

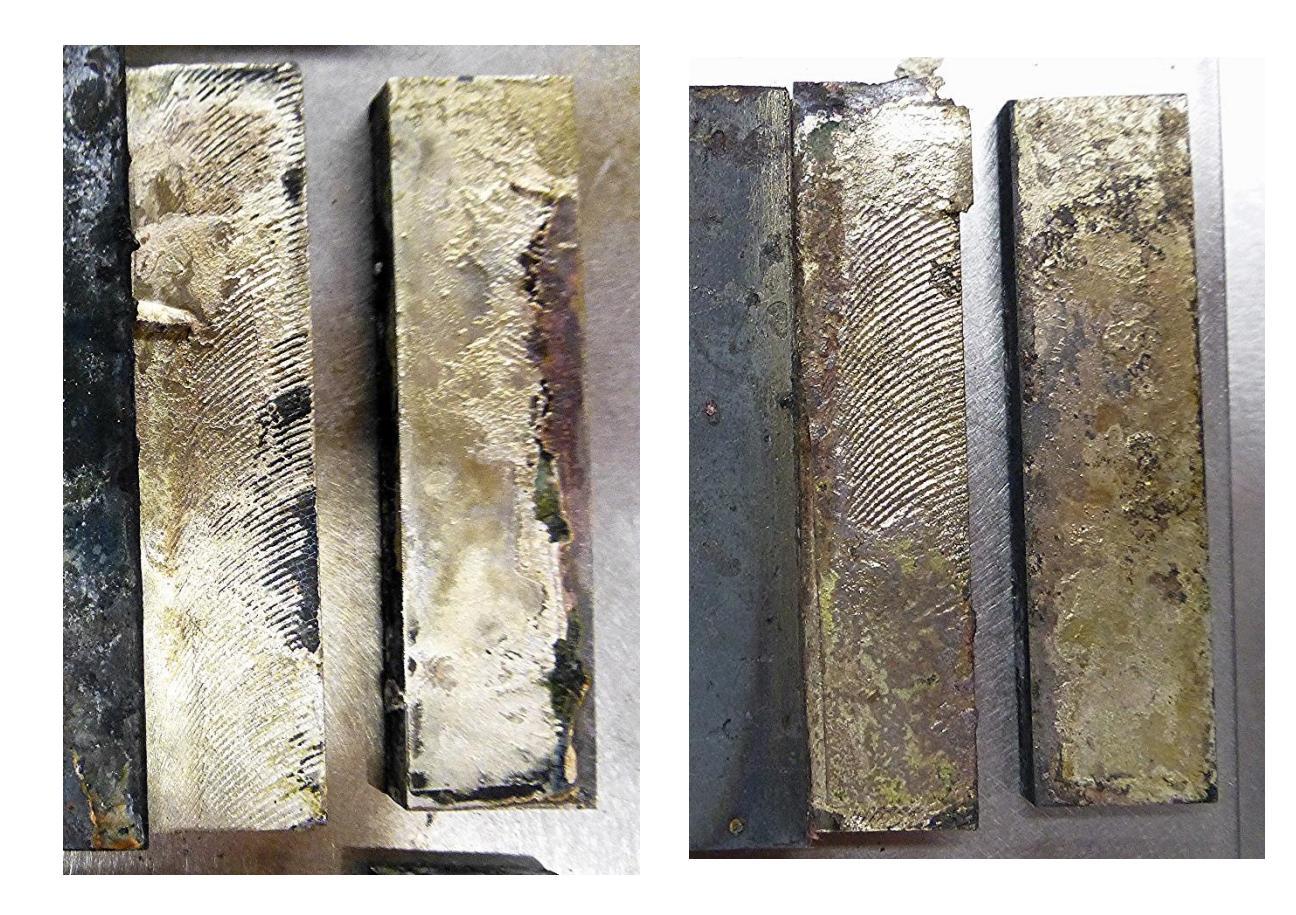
Examination of Parts That Were Brazed, Reheated And Separated.

Curved Marks On The Steel

The curved marks on the steel are from the milling cutter. The cutter used leaves steel very rough and very irregular. The roughness measures as much as 0.004" deep. There is only 0.0025" of braze alloy on this side. Most of the braze alloy disappeared in the valleys or cracks. The heating was uneven so, as soon as one part was hot enough, it drew braze alloy from other parts leaving the voids you see.

Part of the cause of failure was simply a lack of sufficient braze alloy.

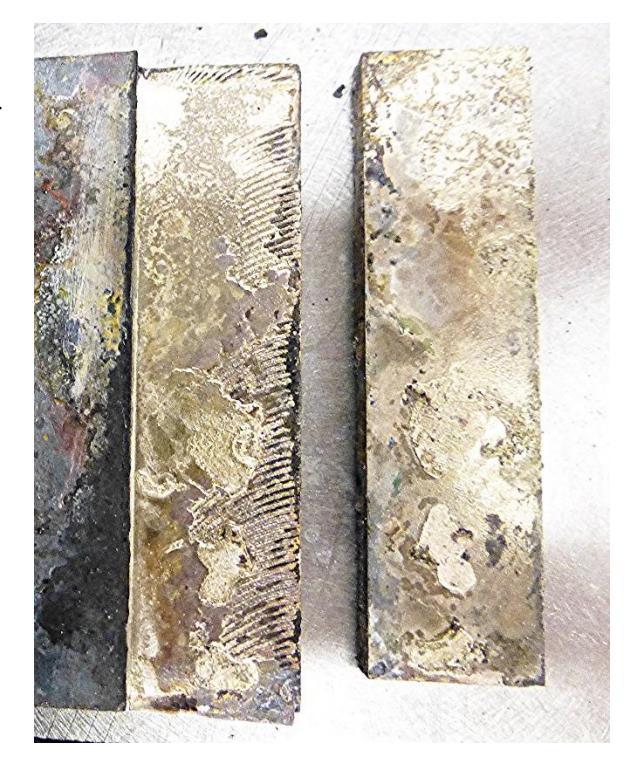
Analysis of the Eveness of the Surfaces

The braze alloy material was specified as 0.750" wide but was delivered at 0.746". Since some of the flats measured as much as 0.800" wide this was significant. The ribbon was simply not wide enough.
