Newsletter June, 2007

## Tip Breakage Report

Zane Lockhart, Jr

MULTI-METALS Division

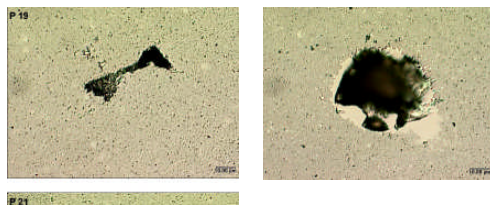
Photo 19 (500X, Unetched) above left

shows a dog-bone shaped defect in a carbide tip. Photo 20 (500X, Unetched) above right shows a very large blow hole. Photo 21 (500X, Unetched) at left shows a cobalt-filled void within the carbide matrix. All of these defects are likely caused by contamination that burned out during sintering process. These deficiencies are not typical of a quality carbide grade.

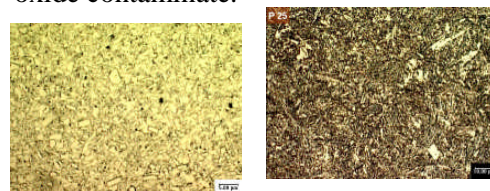
Photo 24 (1000X, Murakami's Etch) above left shows a typical microstructure for the carbide tips. The matrix exhibits a low-cobalt binder with a wide distribution of grain sizes ranging from 0-3  $\mu\text{m}$ . The black spots are bits of fine oxide contaminants.

Photo 25 (500X, 2% Nital Etch) above right shows a typical microstructure for the steel plate. The plate matrix exhibits a hardened-and-tempered martensitic matrix that is typical of steels hardened by heat treatment. No deficiencies were found in the steel.

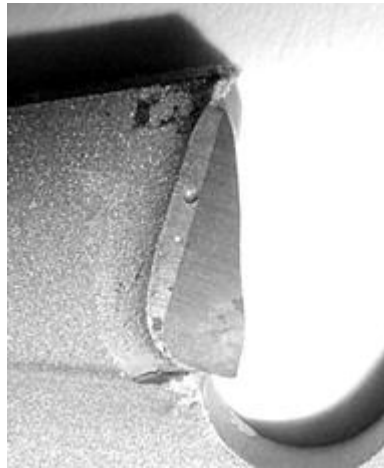
Braze alloy joins the parts together. It also serves as cushion between the carbide and the steel. As you braze the the steel grows about 2.5 to 3 times as much as the steel. When it cools and shrinks this stresses the carbide and can cause carbide fracture during grinding and during use.

You need a thick layer of braze alloy between the carbide and the steel to compensate for thermal stress.

Here is a broken tip. There is huge amount of braze alloy that has been pushed out the side. You can see by the flow of alloy onto the plate that the temperature control was good and the plate was clean. **Too much pressure was used to seat the tip and too much braze alloy was pushed out the sides.**

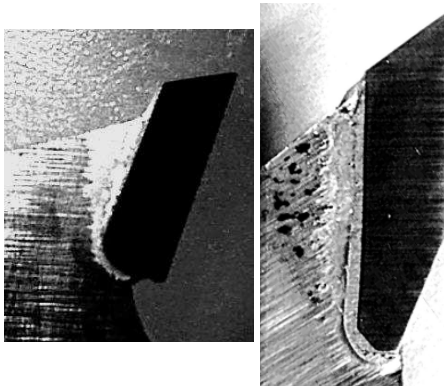
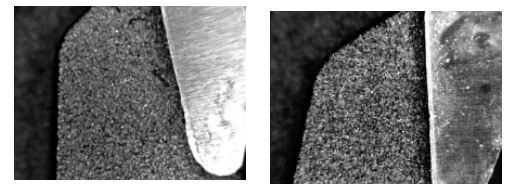
Here are two more tips with the same condition. In this case the tips have not broken but others on the same saws did break either during grinding or during use.

Here are some really good brazes. After grinding there is only a very thin line of braze alloy behind the tooth. These are at 30 power magnification.
