Northwest Research Institute, Inc. Carbide Processors, Inc. 3847 S. Union Ave. Tacoma, WA. 98409 800 346-8274

Carbide Braze Failure Due To Machining Of the Steel Holder

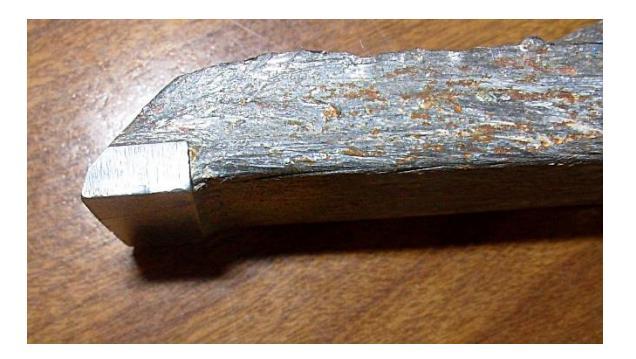
This project was the brazing of a rectangular blank into a steel holder for use as a scraper. The carbide was brazed into place and then the bevel was ground on the front face.

The brazing have been going very well with zero failure for a few years and then suddenly the carbide started coming off and/or breaking during grinding.

The braze alloy was 0.010" thick Trimetal (also called Plymetal or sandwich ribbon). This provided for a 0.0025" (2.5 / 1,000) thick layer of braze alloy on each side of the copper center.

The carbide was flat and square. It wet out very well.

The parts were assembled using the back of the notch as a reference.
